# Manhole Inspection Summary

Manhole # S53K\_\_031MH

Insp Date: **4/8/08 10:21 AM**

**Location** Address: **3302 Fait Av**

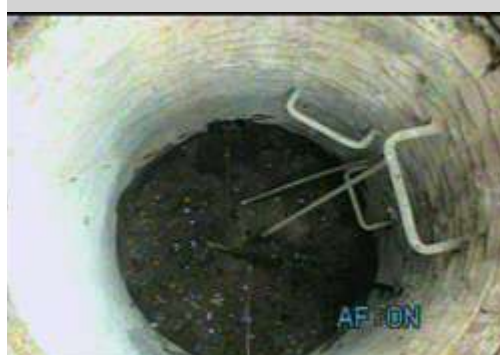
Top View

Diameter: **26** (in.) Length: **0** (in.) Dist A/B Grade: **1** (in.)

cover above grade in sidewalk

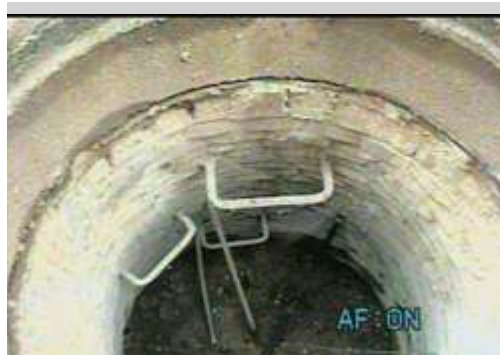
Defect 3

channel debris

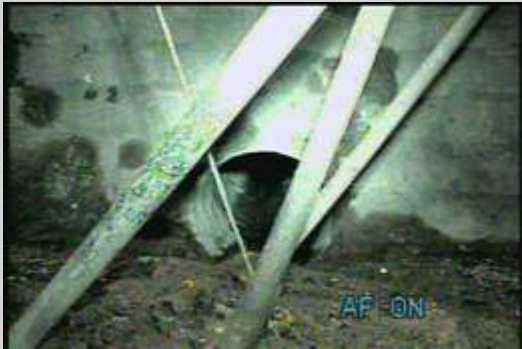
12 O'Clock Outflow

8 in. Circular Gravity Sewer  
Pipe Out @ 12 O'Clock
